WI/FEP-01-98

LIVING NOISE BARRIER

FINAL REPORT

JANUARY 1998

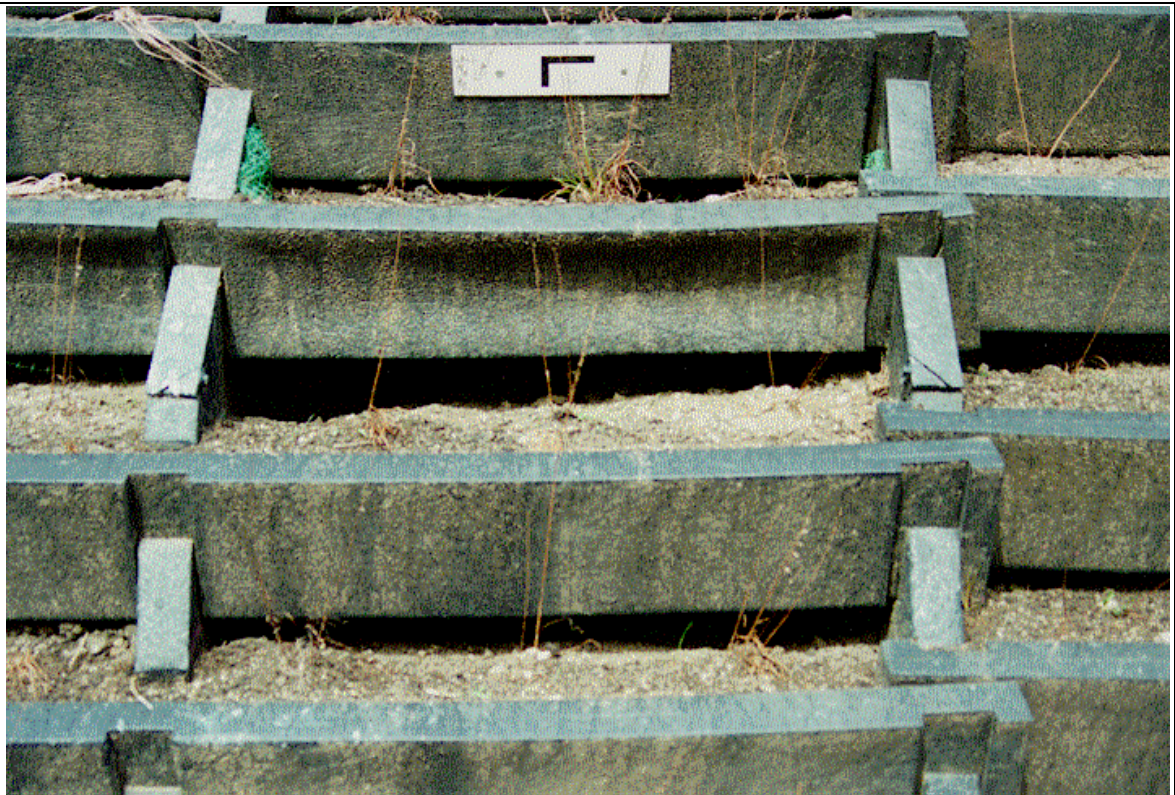
Photograph 11: Loss of soil is evident along the bottom of horizontal members.

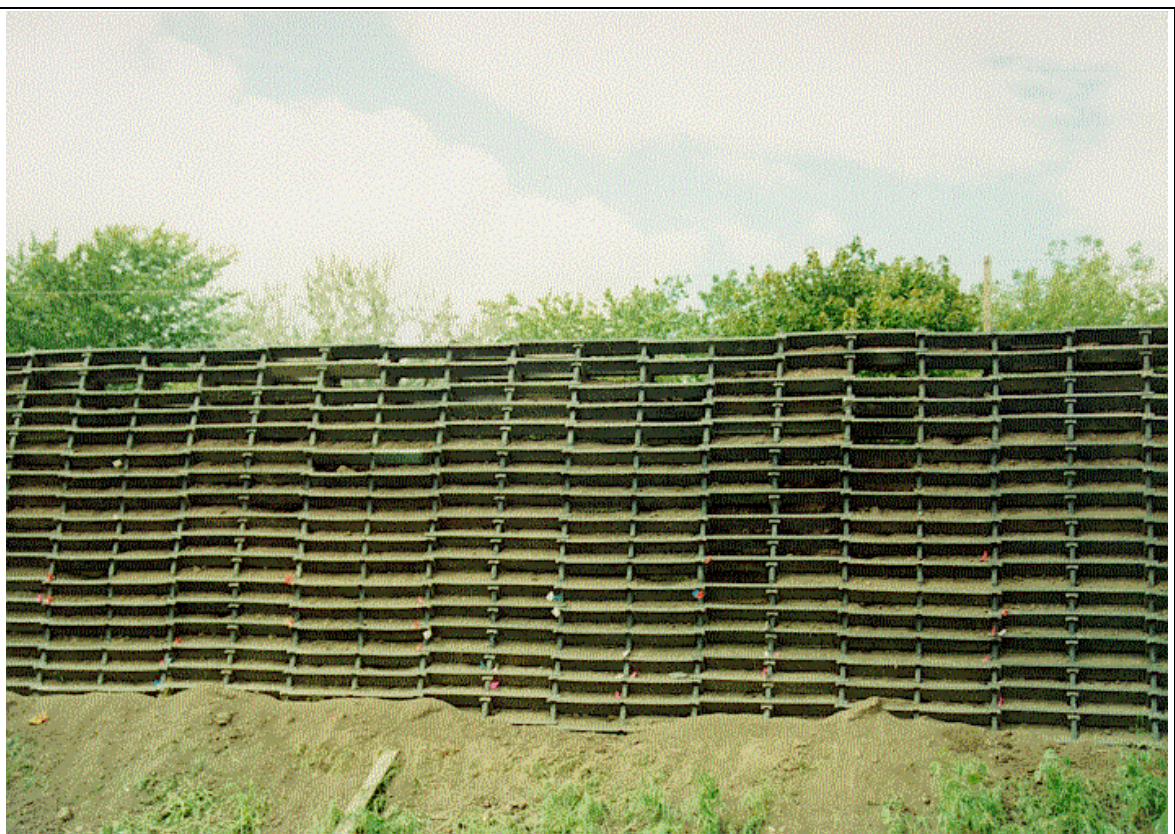
Photograph 12: Large soil voids occurred throughout the structure.

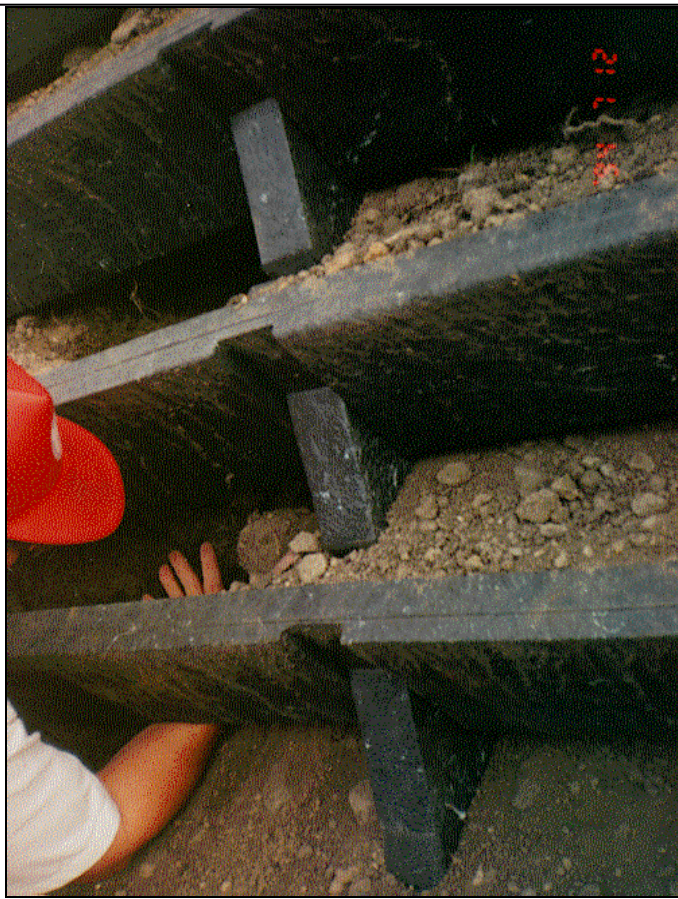
Photograph 13: Large soil voids in planting cells

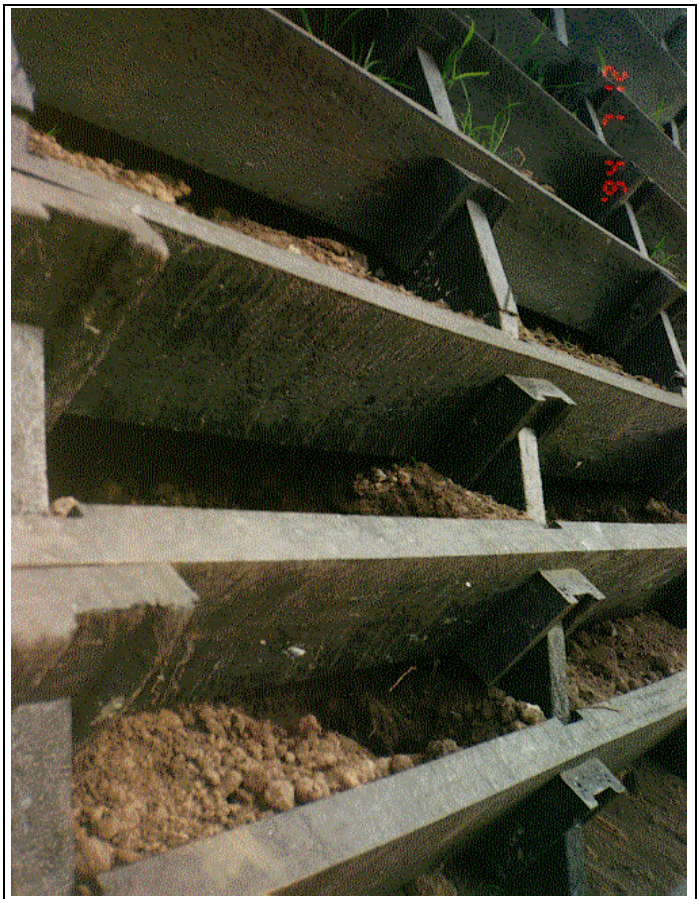
Photograph 14: Large soil voids in planting cells.

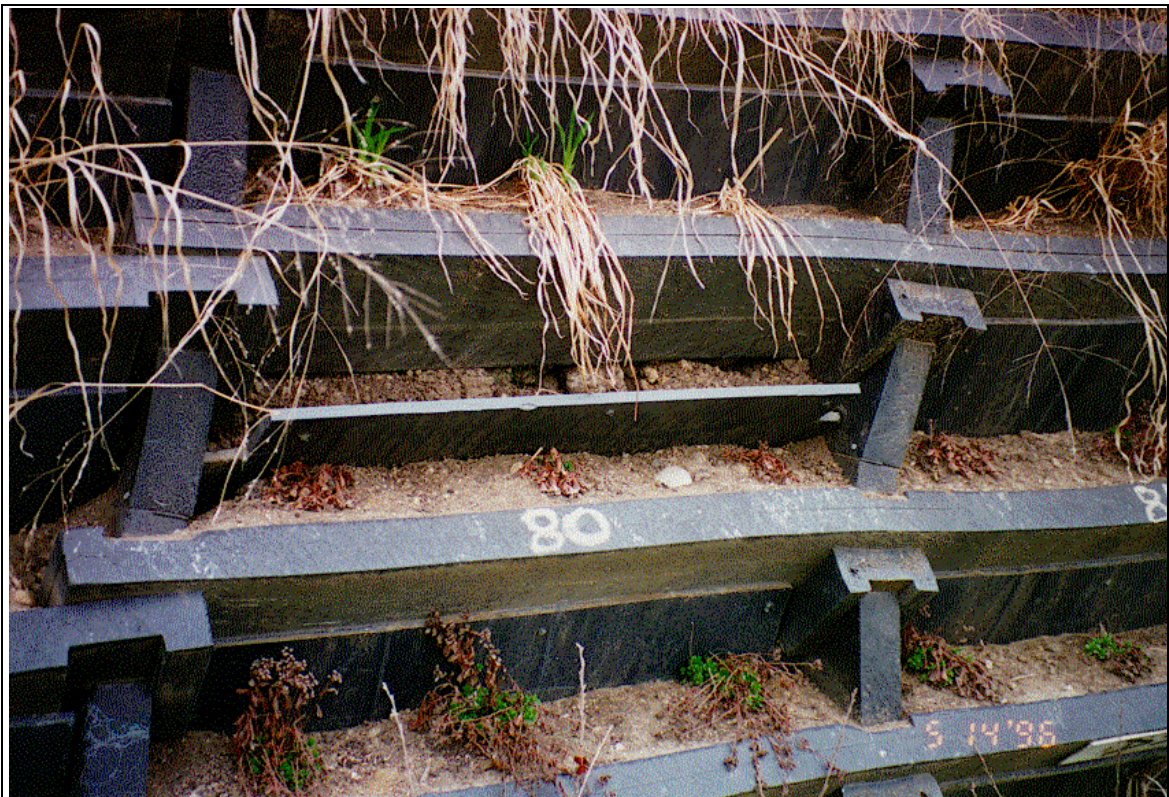
Soil loss from the structure was also discussed earlier in this report. The plastic extensions which were attached to the horizontal members effectively eliminated soil loss from the planting compartments. However, cracks became evident in a small number of the plastic extensions and several of the screws which were fastening the extensions came loose from the horizontal members. This did not appear to be a significant concern and required only that the extensions be replaced or refastened.

Photograph 15: Horizontal members with retrofitted extensions.

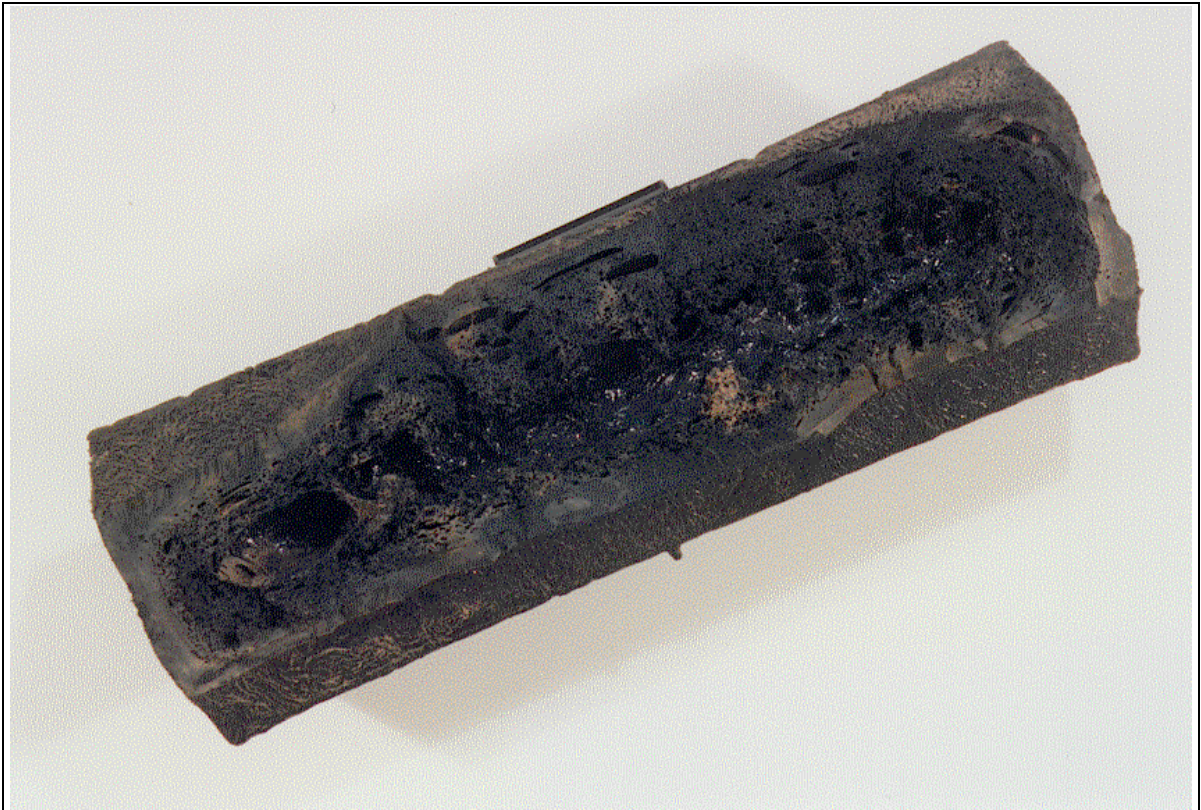
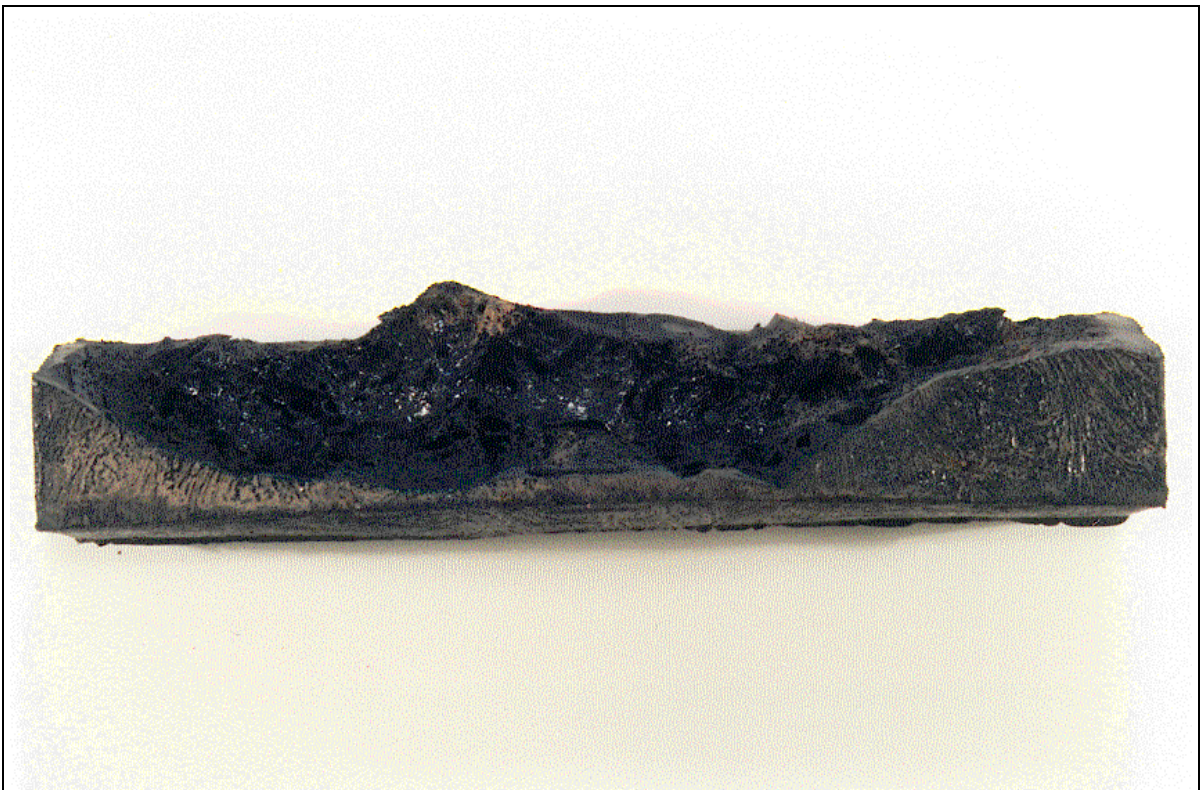
The last structural concern was the breakage of part of one horizontal member. The interlocking tab which holds the horizontal member to the vertical support had broken off. The horizontal member remained in place although it was not interlocked with the vertical support.

Of greater concern was the physical make-up of the broken horizontal member. At the place of the break, the interior was almost entirely devoid of plastic. Apparently, a large air bubble had settled in this location during the fabrication process. Approximately 6.3 mm (1/4-in.) of solid plastic made up the exterior of the 50 mm (2-in.) thick section. Another 6.3 mm (1/4-in.) was made up of very porous plastic between the solid plastic exterior and the air bubble. The member was structurally incapable of handling the applied forces. Photographs 16 and 17 (page 31) show the broken section of the horizontal member.

Photograph 16: Air bubbles and porosity are evident in a broken horizontal member.

Photograph 17: Air bubbles and porosity are evident in a broken horizontal member.

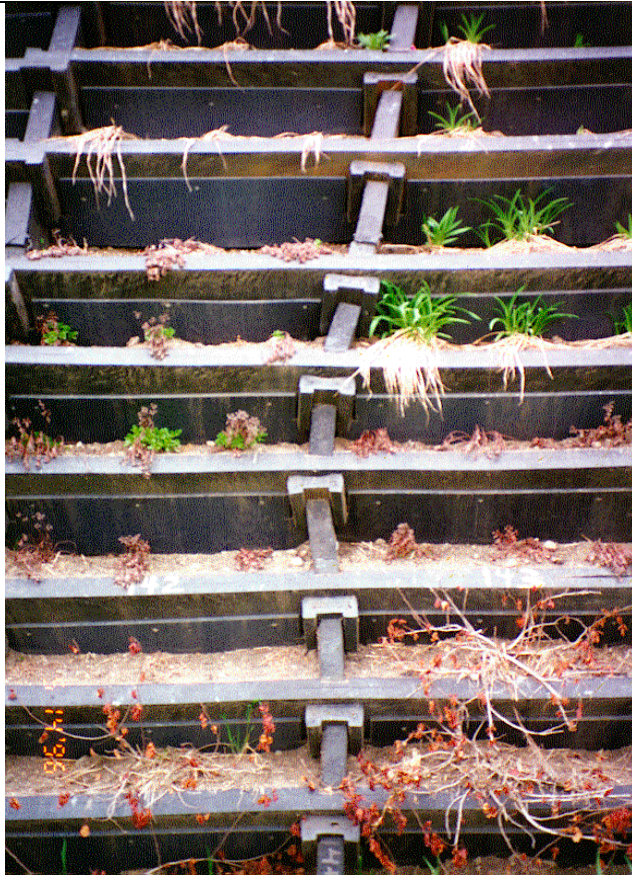
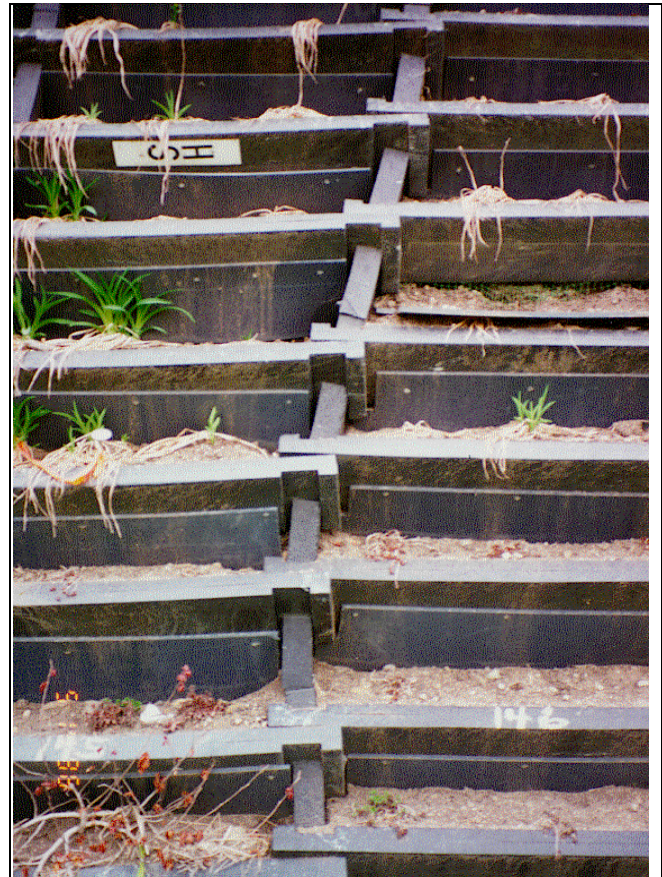
Photograph 18: Deformation in the vertical supports.

Photograph 19: Deformation in the vertical supports.

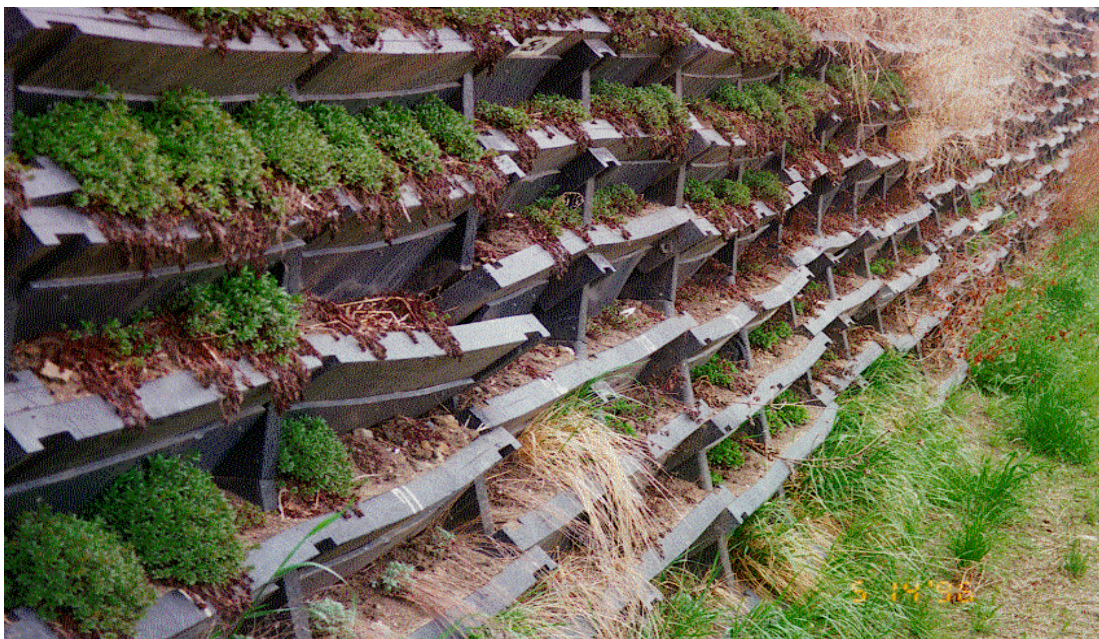
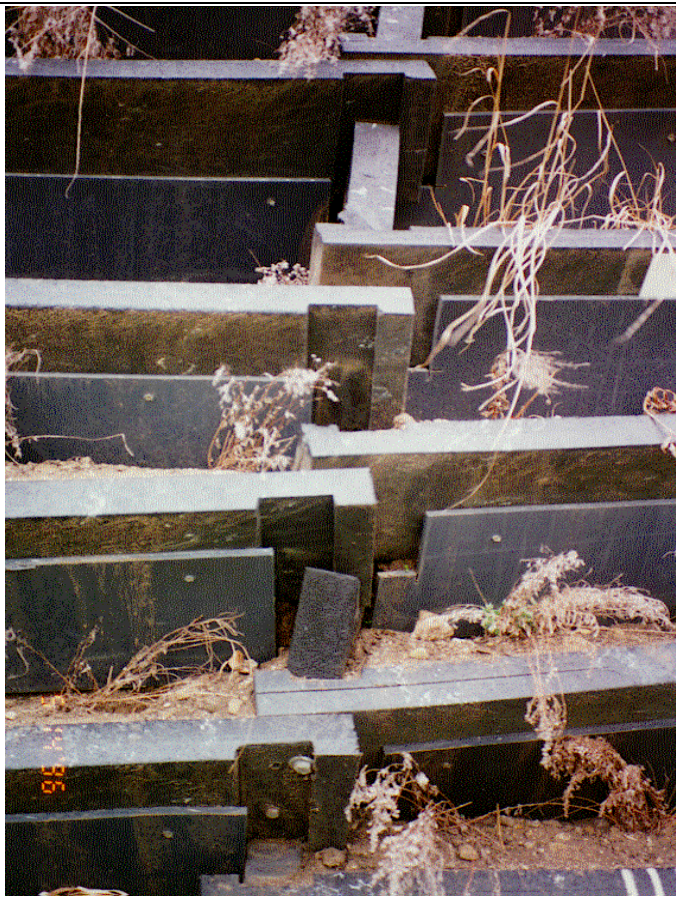
Breaks in more of the plastic members were also observed. The sections of the vertical supports which directly supported the horizontal members began to shear off. After the supports sheared off, the horizontal members would fall onto the next lower level. In one localized section, several supports in a row broke off and two of the horizontal members fell off of the structure. The soil then began falling out from the interior of the structure onto the ground. This localized breakage progressed until there was a hole in the structure measuring approximately 4 meters (13 feet) x 2 meters (6.5 feet), and much of the soil which had filled that area was piled at the base of the structure. See Photographs 20 through 24 (pages 32 through 34).

Photograph 20: Sections of the vertical supports which held the horizontal members in place began to break off.

Photograph 21: Sections of the vertical supports which held the horizontal members in place began to break off.

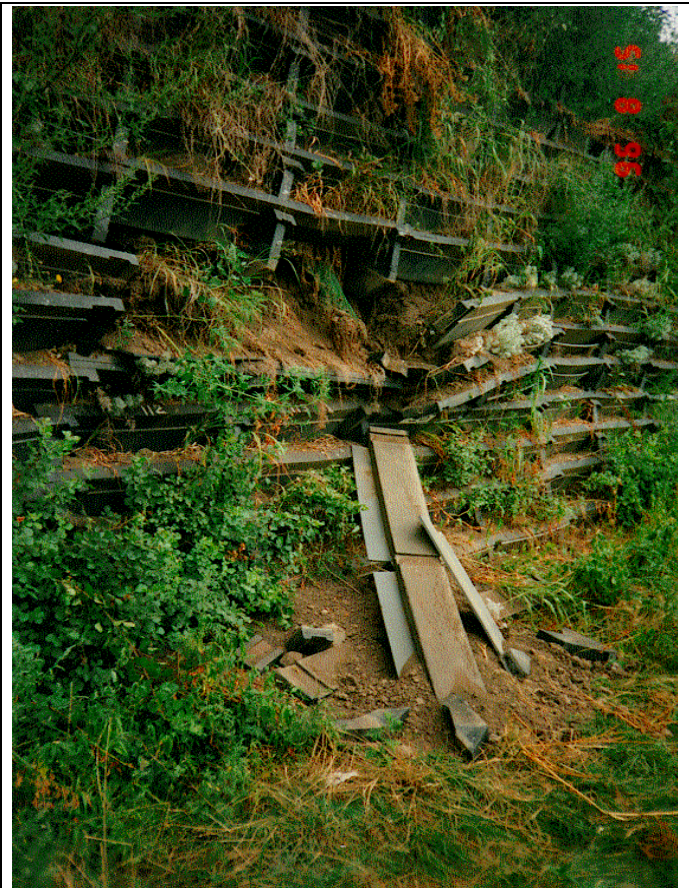
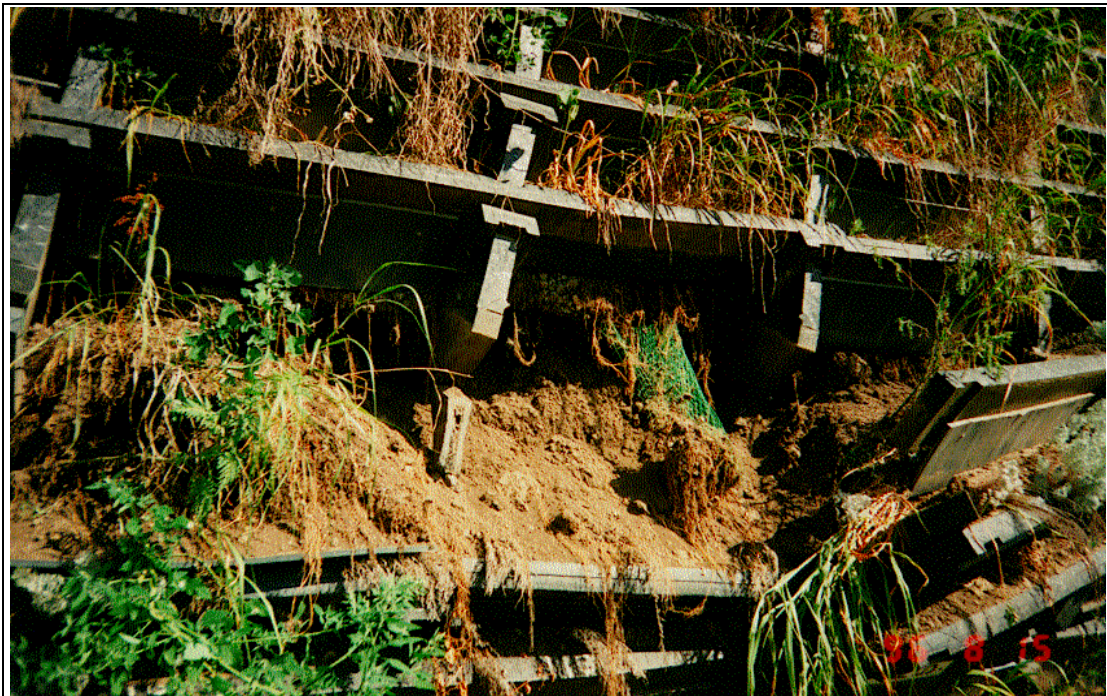
Photograph 22: After the vertical supports broke, the horizontal members began to fall out.

Photograph 23: After the vertical supports broke, the horizontal members began to fall out.

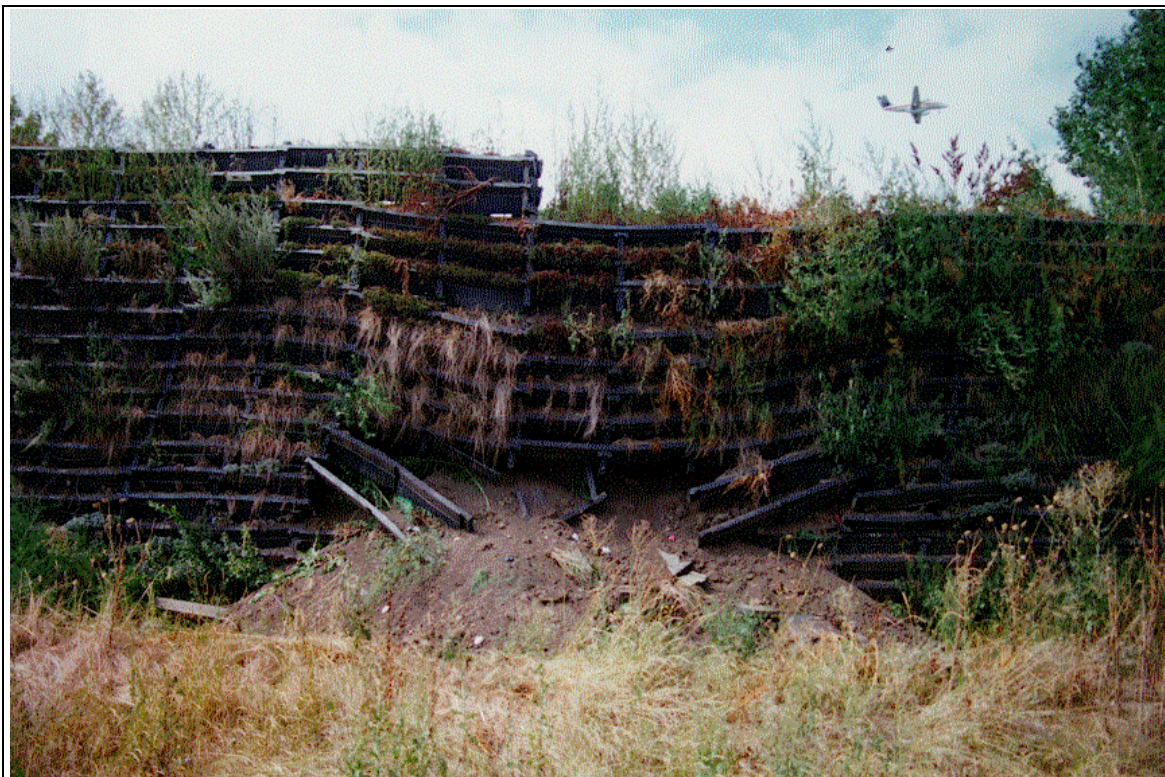
Photograph 24: The plastic frame continued to break, allowing the soil to fall out.

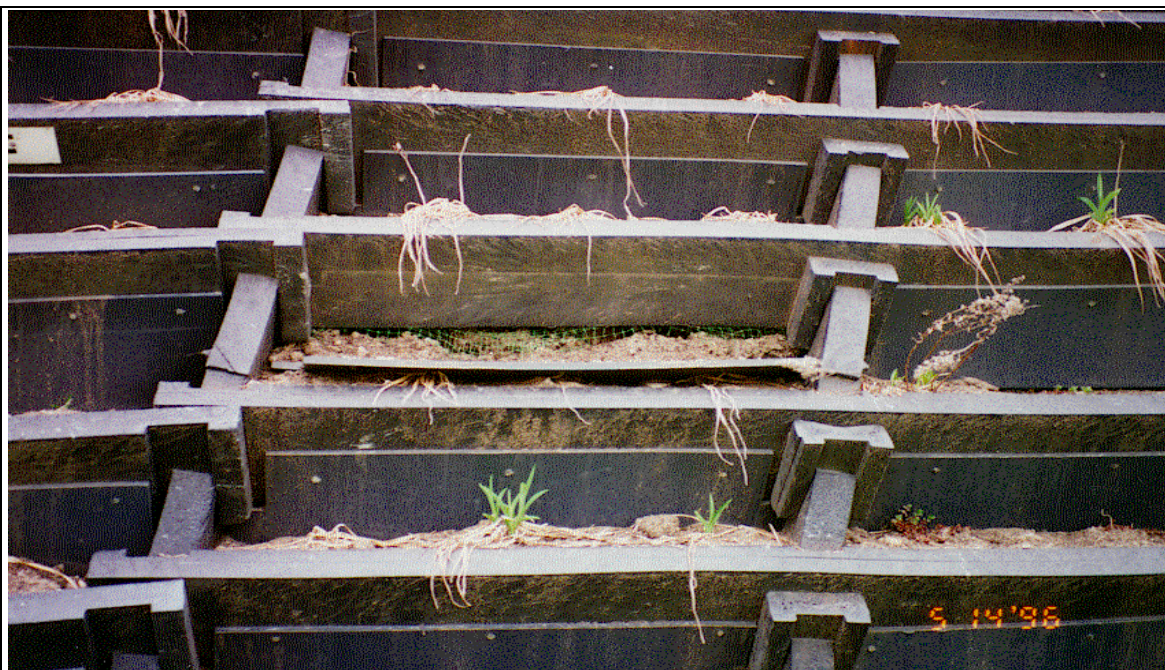
The plastic extensions to the horizontal members were cracking and many of the fasteners were pulling out (Photograph 25, page 34). When the extensions cracked or separated from the horizontal member, the soil would again begin falling out. This resulted in many small soil voids throughout the structure.

Photograph 25: As the vertical and horizontal members deformed, the plastic extensions began breaking away from the horizontal members.

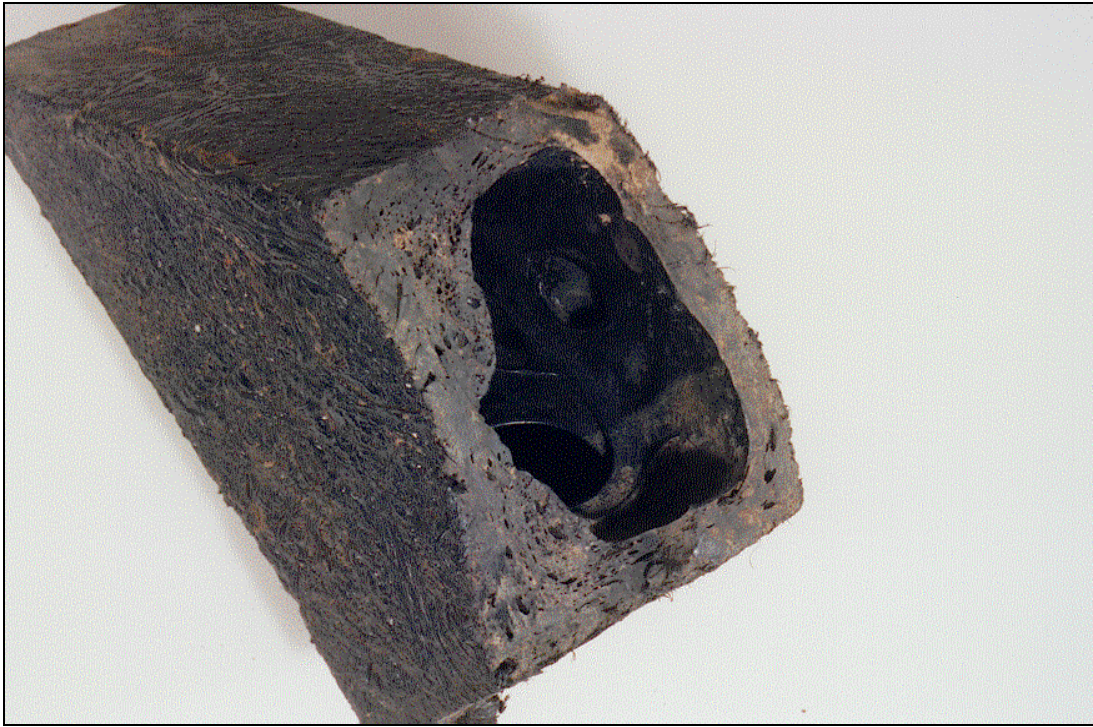
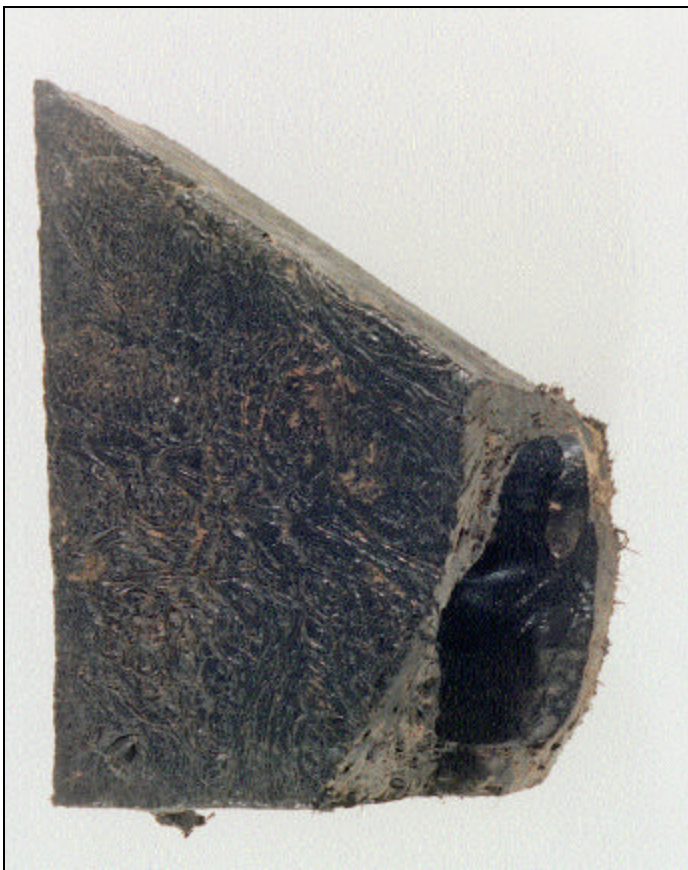
At almost all shear and breakage locations, air voids and porosity were observed in the interior of the plastic members. Some of the members had as little as 6.3 mm (1/4-in.) of solid plastic around the periphery, with the remainder of the section made up of an air bubble or very porous plastic. This was the major cause of these failures and points to a quality control problem during manufacturing. Photographs 26 and 27 (page 35) show a sheared off portion of a vertical support.

Photographs 26 & 27: The interior of this piece of a vertical support does not contain any plastic. The plastic around the peri-phery contains many small air bubbles.

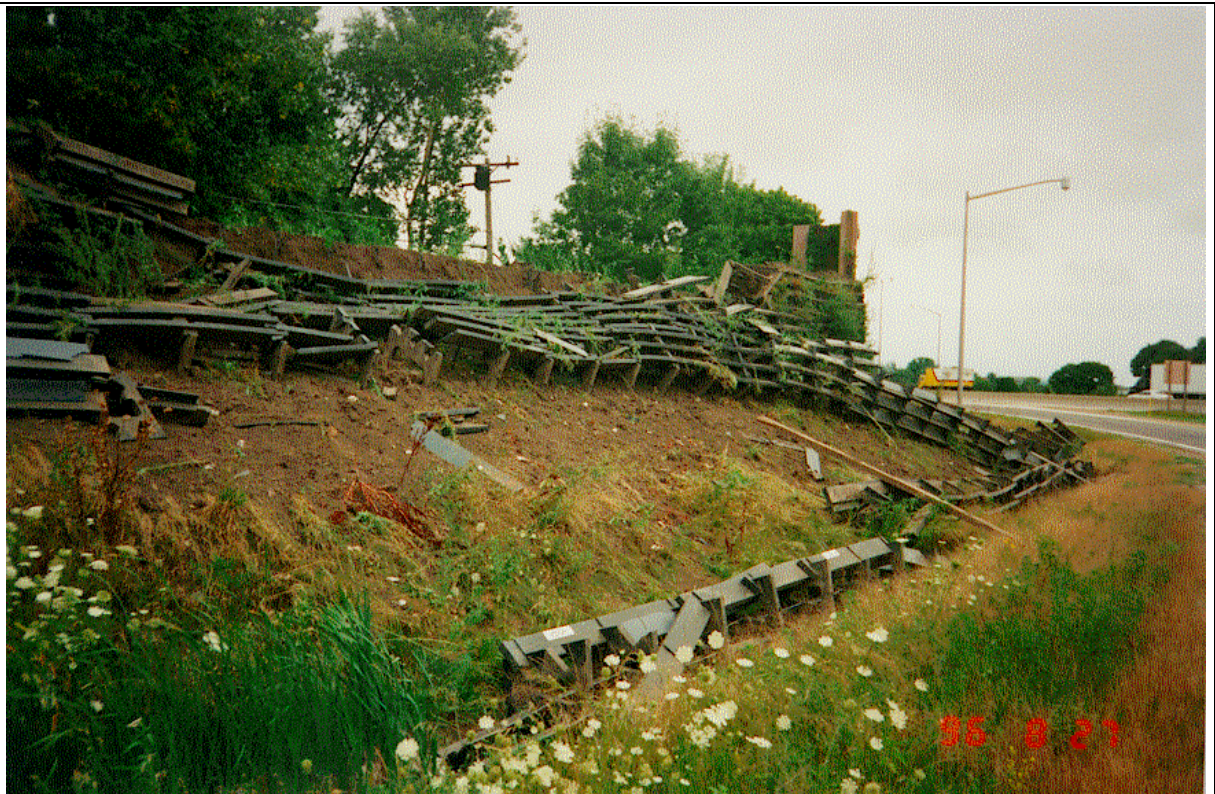
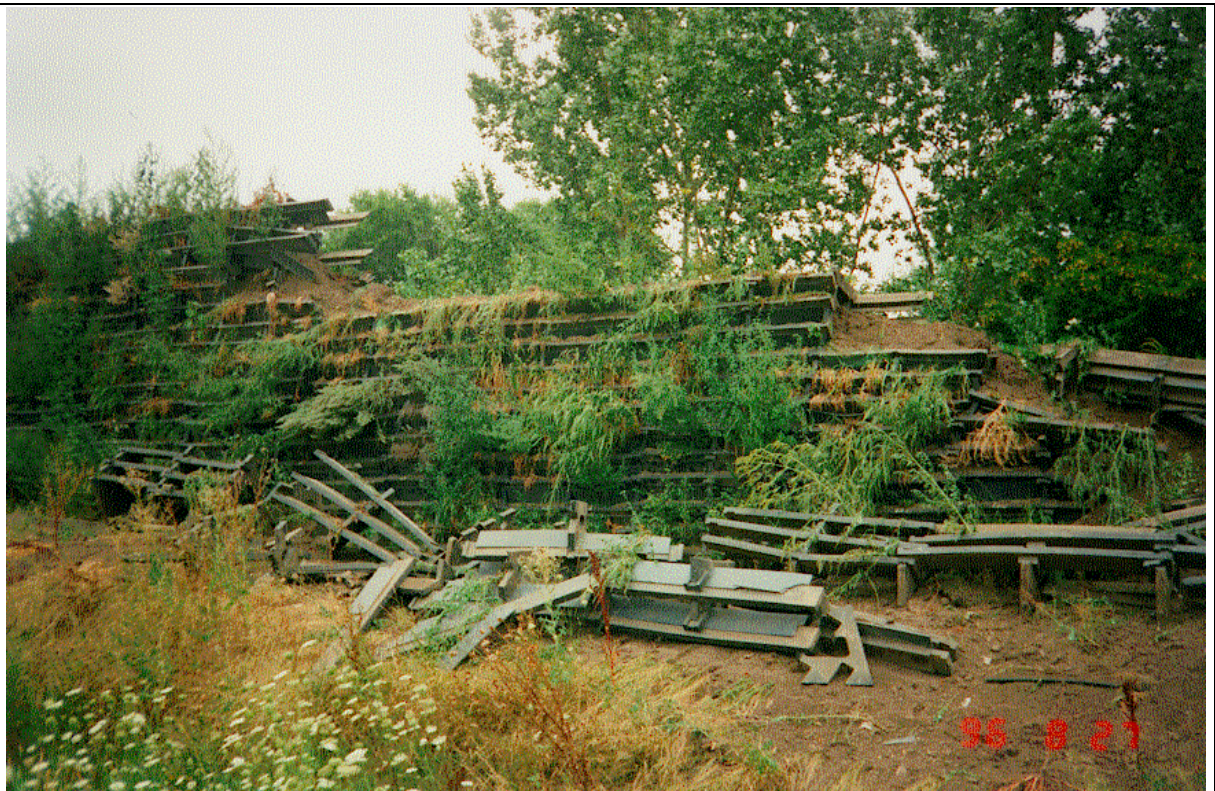
Upon inspection, many of the vertical support members appeared to be torn in half, indicating that the cause of the collapse was directly related to failure of the plastic support system. However, several contributing factors were identified:

- Soil voids reduced the bearing capacity in the middle third of the structure. Since the soil and plastic frame were designed to work as one system, the support strength was greatly reduced after soil in the mid-section began falling out. Only the plastic framework was left to support the upper section of the soil core. This contributed to the excessive deformation and ultimate failure of some of the plastic supports.

- The moisture content in the soil core was very low, causing the entire core to shrink. As the soil core shrunk and consolidated, lateral support for the vertical members, provided by contact with the surrounding soil mass, was greatly reduced. The downward force of the soil mass continued to be applied to the horizontal planks, which were attached at each end to the vertical members. This resulted in the movement and deformation of the vertical members, causing them to appear “snake-like” and out of plumb, instead of straight and vertical. This also may have caused excessive stresses to be applied to the plastic framework contributing to the failure.

- High temperatures caused by the sun appear to have contributed to the weakening of the plastic framework. Deformation of the plastic was much more extensive on the sunny side than on the shaded side, and breakage of the horizontal members occurred only on the sunny side. The black plastic was warm on sunny winter days and was very hot on sunny summer days. The temperature of the plastic on the shaded side remained at approximately the same temperature as the air.

Photograph 32: Collapsed section of the barrier.

Photograph 33: Collapsed section of the barrier.

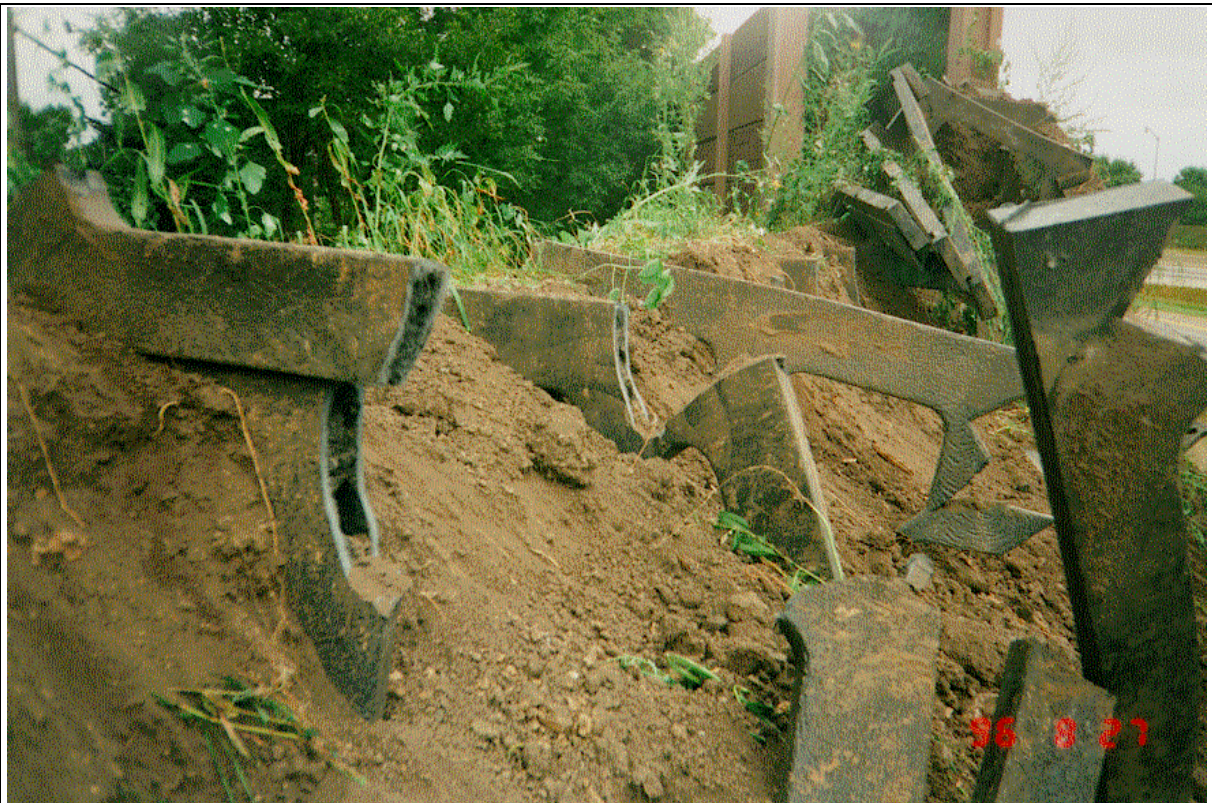
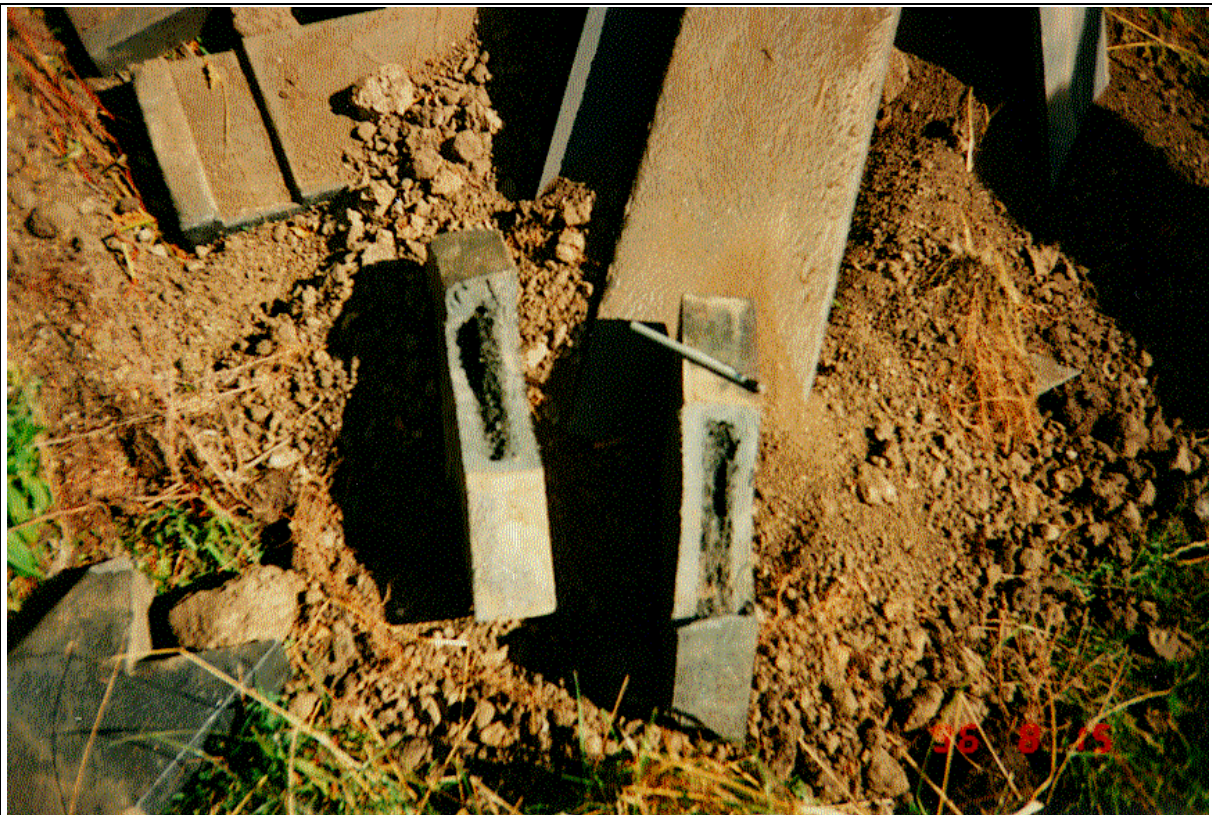
- Porosity and large air bubbles were evident in almost all of the broken plastic support members. A lack of quality control during the manufacturing process may have caused this to occur. The strength in the air bubble areas was greatly reduced and these sections were more susceptible to failure than the rest of the members. Broken sections showing air bubbles and porosity are shown in Photographs 34 and 35 (page 39).

3. The recycled plastic members contained internal air bubbles and porosity. Areas which failed were observed to contain excessive amounts of air voids instead of solid plastic. The lack of structural integrity of the material appears to be the major factor in the failure.

Photograph 34: Large air bubbles and porous plastic were evident in the broken plastic frame.

Photograph 35: Large air bubbles and porous plastic were evident in the broken plastic frame.

Based on the strength and temperature characteristics of plastic, WisDOT's experience with Recywall, and other instances where plastics were used in a structural capacity, it is the recommendation that non-reinforced plastics, either virgin or recycled, not be used as structural members of any kind.
